Cortina Systems[®] LXT971A, LXT972A, LXT972M Single-Port 10/100 Mbps PHY Transceivers

Specification Update

Document Number 249354

Revision 13.0

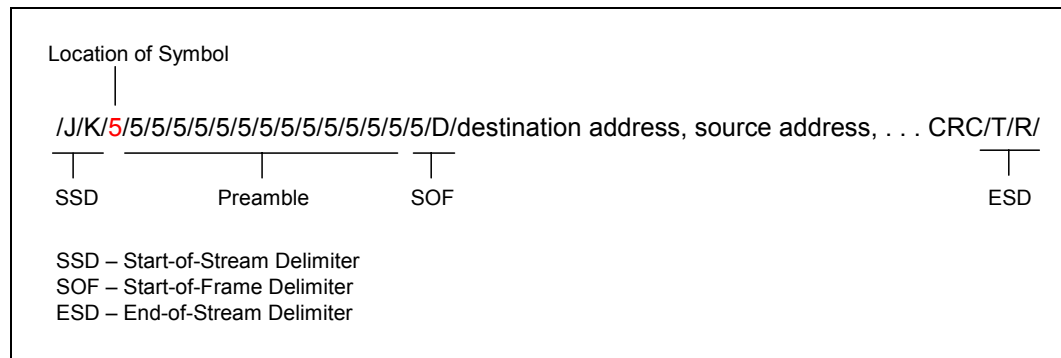
Standard Frame Contents:

Item 15: Detection of Illegal Symbols After SSD

Problem An illegal symbol placed immediately after the SSD (preamble after JK) is not detected. However, any subsequent corrupt symbol will be detected.

Implication RXER does not assert if this symbol location is corrupted. However, an error in this location does not affect packet integrity.

Workaround Use the MAC layer protocol to detect corrupt symbols in the packet.
